# Existing Conditions Summary

Whitefish Rail Crossing Study

Description of data collection and analysis efforts and summary of existing crossing characteristics

*Whitefish, MT*  
November 7, 2025

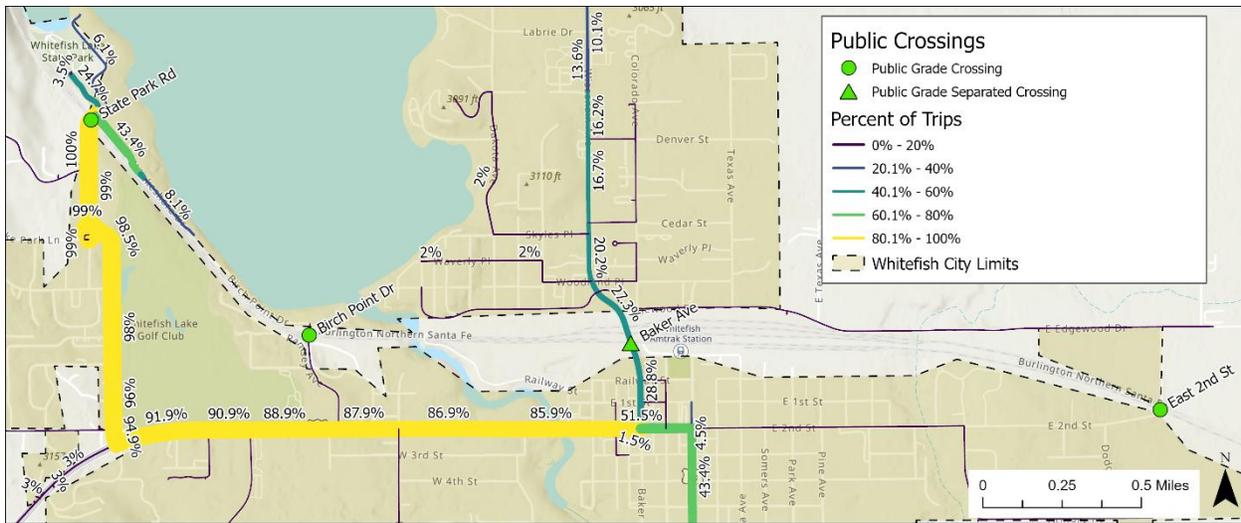
Figure 2-1. Travel Patterns – State Park Road

Figure 2-1 displays the estimated travel patterns for State Park Road crossing users. The largest percentage of trips use State Park Road and 2<sup>nd</sup> Street to travel into central Whitefish. Only an estimated 3% of trips travel to and from the west of central Whitefish. Once in Whitefish, the trips generally split with approximately 43% traveling south on Highway 93 and 28% of trips traveling north over the Baker Avenue grade separation.

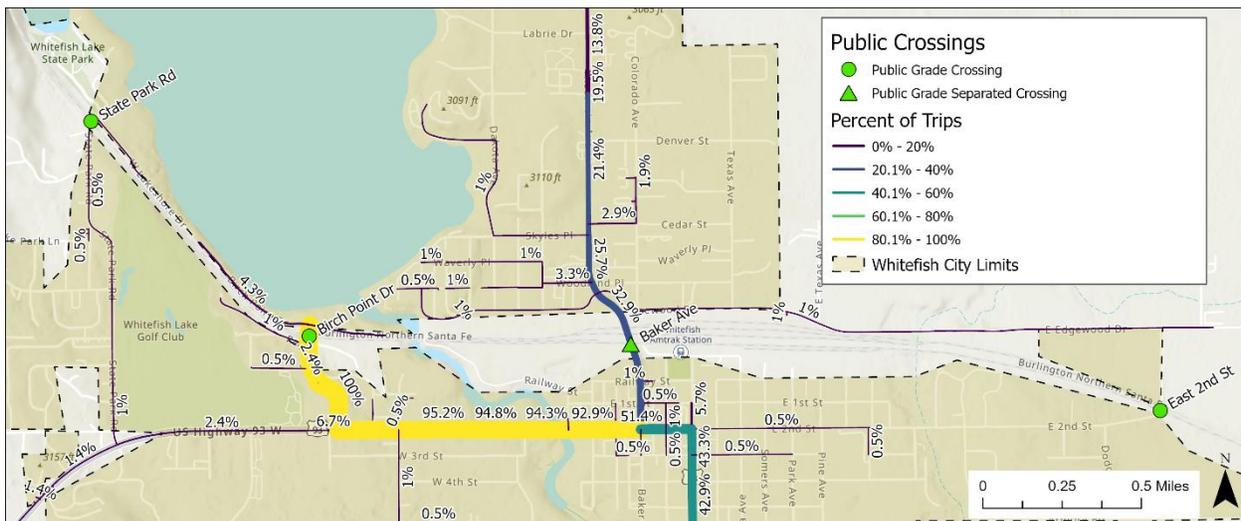
Figure 2-2. Travel Patterns – Birch Point Drive

Figure 2-2 displays the estimated travel patterns for Birch Point Drive crossing users. The largest percentage of trips use Birch Point Drive and 2<sup>nd</sup> Street to travel into central Whitefish. Approximately 7% of users travel west of central Whitefish. Similar to trips using the State Park Road crossing, trips into and out of central Whitefish split with approximately 43% traveling south on Highway 93 and 33% of trips traveling north over the Baker Avenue grade separation.

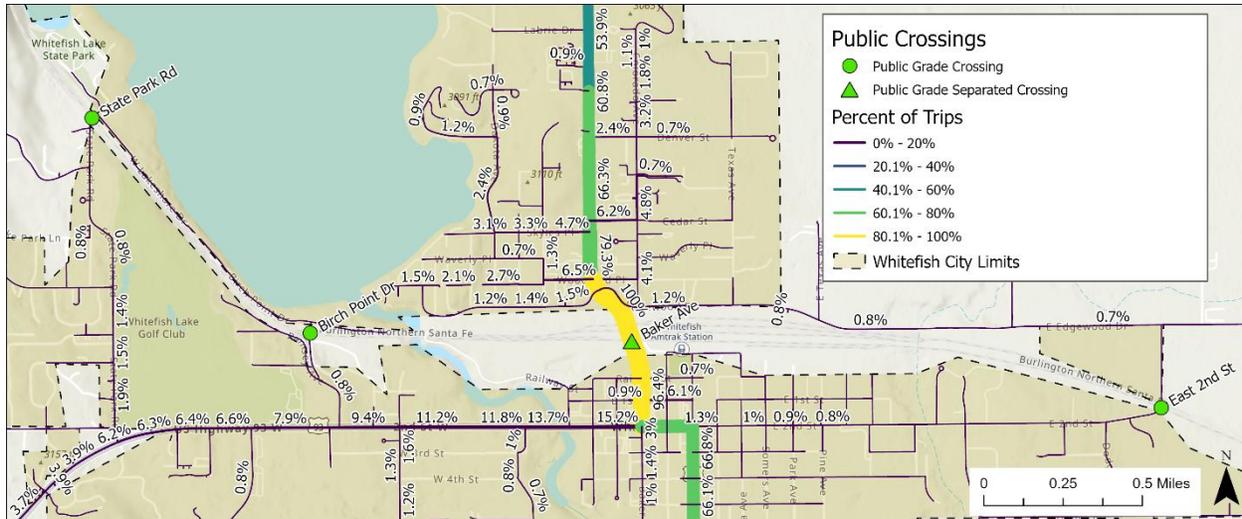
Figure 2-3. Travel Patterns – Baker Avenue

users continuing north on Wisconsin Avenue or south on Highway 93. Smaller percentages of these trips extend into other areas of Whitefish on both sides of the BNSF rail line.

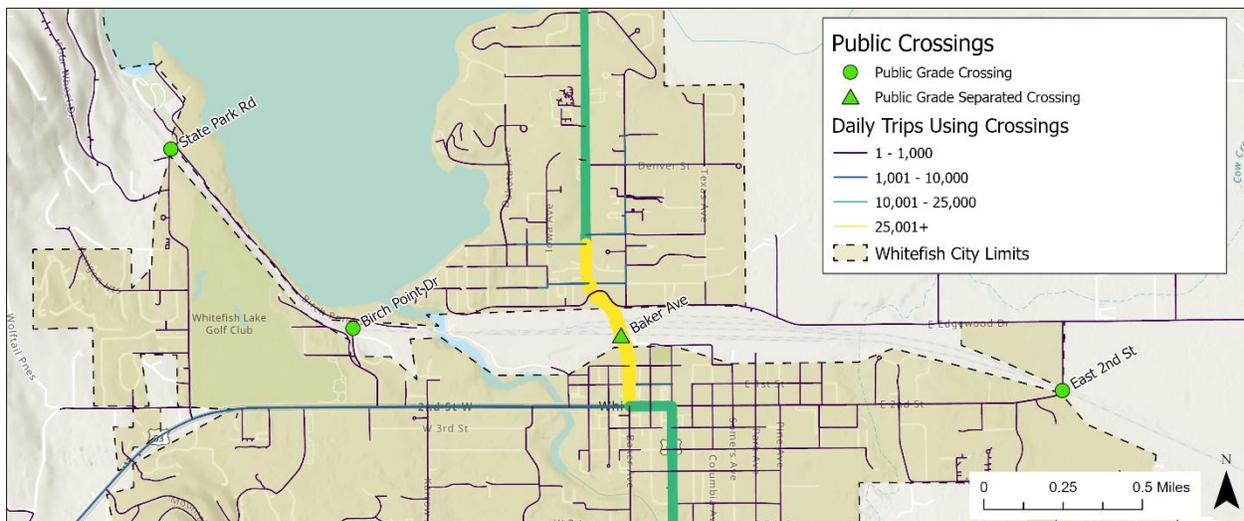
Figure 2-5. Travel Patterns – All Crossings

The result of combining the travel patterns for all four crossings is shown in Figure 2-5. This figure highlights the importance of Baker Avenue as the primary north-south crossing point over the rail line. E 2<sup>nd</sup> Street is the only other crossing that provides access to the northern parts of the city but is primarily used for trips to and from areas to the east of Whitefish.

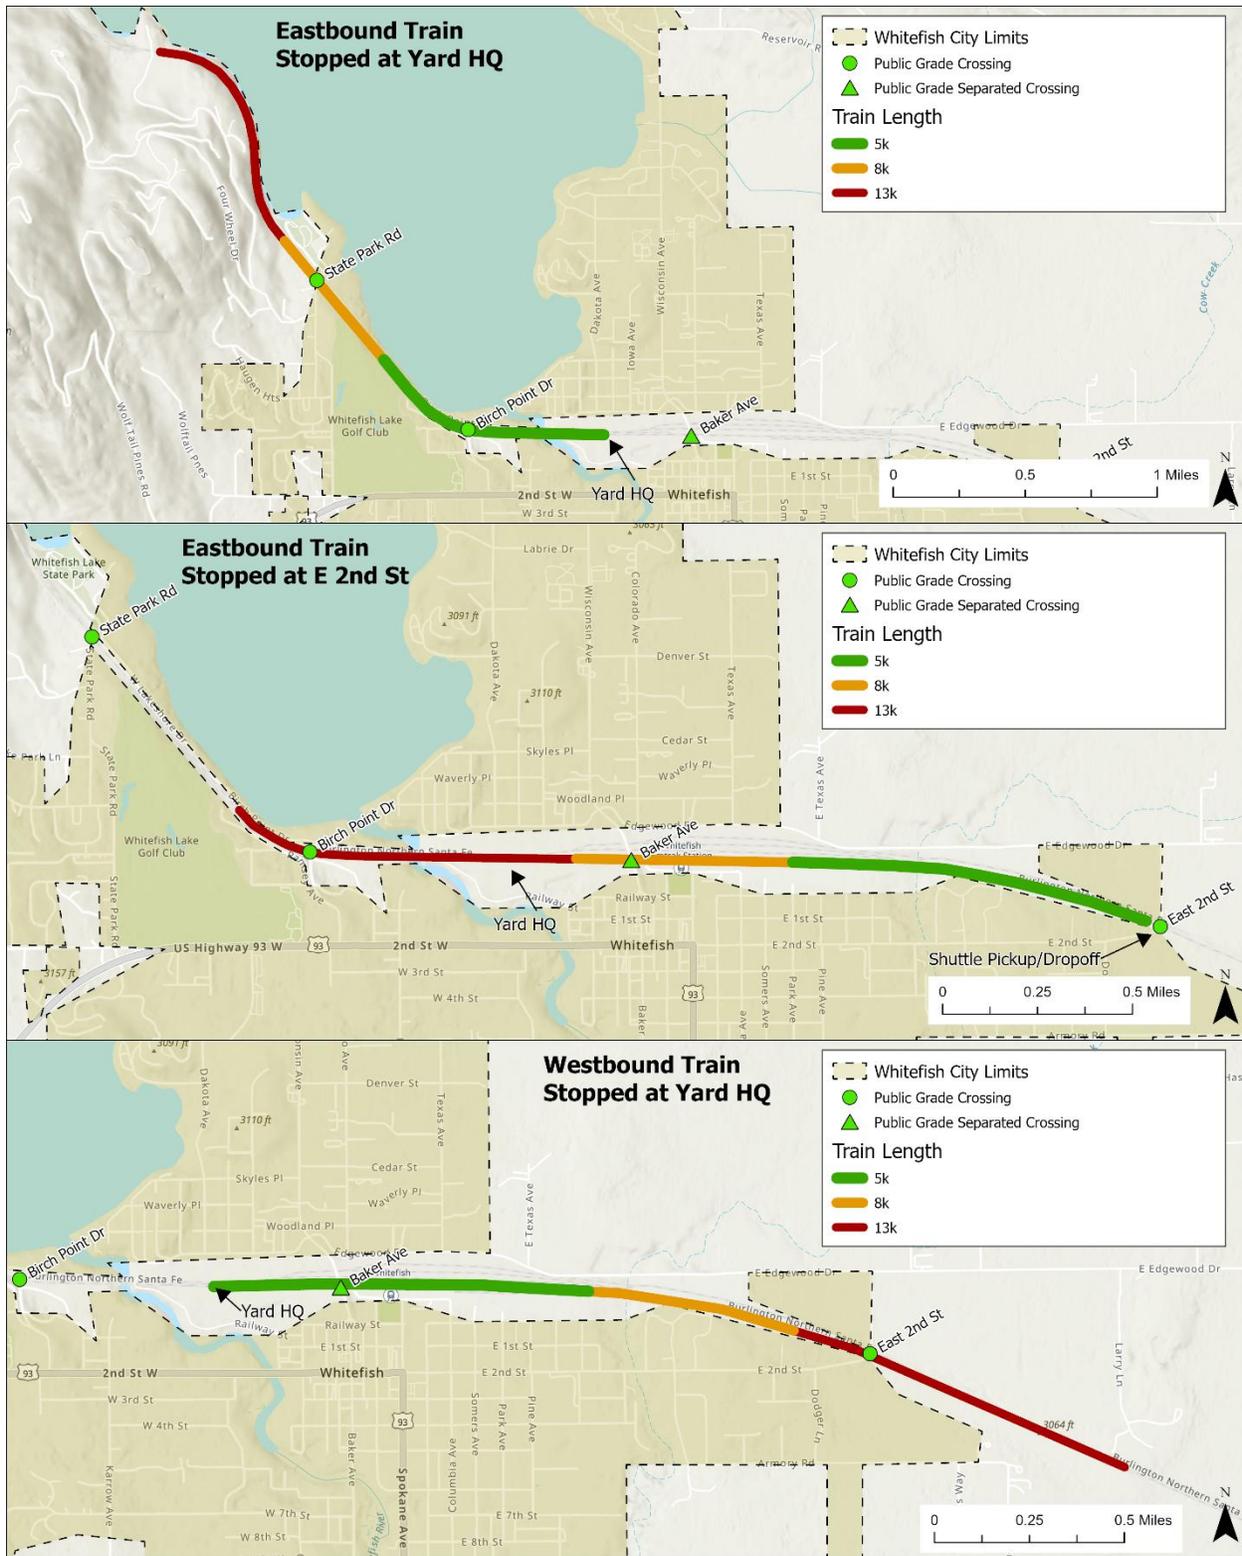
Figure 2-7. Train Lengths and Crossing Blockages

Figure 2-7-7 visually displays the impacts of different train consist lengths on crossing blockages eastbound and westbound. Trains are shown at lengths of 5,000 feet, 8,000 feet, and 13,000 feet. The top graphic displays previous operations with an eastbound train stopping at the BNSF yard headquarters (or terminal) for the purposes of crew changeovers. In this case, trains of all lengths blocked the Birch Point Drive crossing, trains at 8,000 feet and over blocked the State Park Road crossing. During the field review, BNSF noted that these crew changes had been adjusted to reduce some of these crossing blockages by conducting the crew changes closer to the E 2<sup>nd</sup> Street crossing as shown in the middle graphic. The bottom graphic displays similar operations for westbound trains.

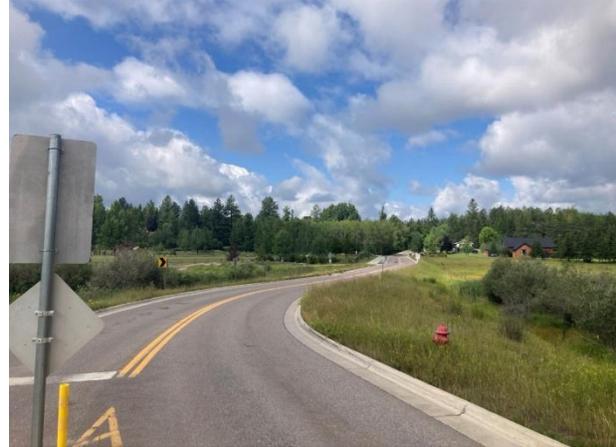
Figure 4-2. South of Crossing, From South End of Median Looking Southwest Along Roadway.

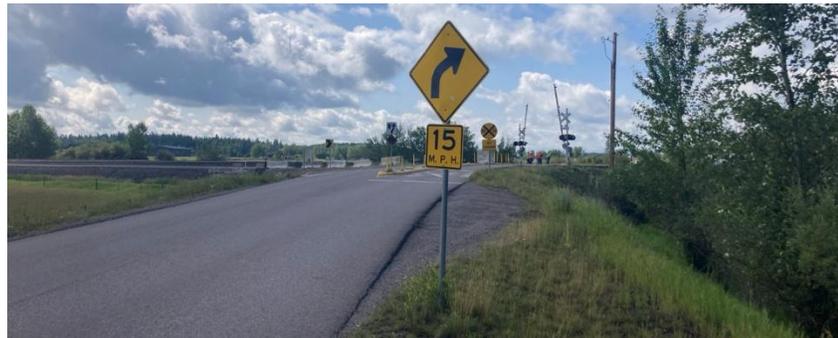
Stopping sight distance at the crossing is somewhat impacted by shrubs and foliage in the northwest and southeast quadrants. Both stopping sight and sight triangle distances have the potential to be impacted by the presence of stopped trains on one track

obscuring the view of trains approaching on adjacent tracks. The diagnostic team did not identify stopping sight distances as a concern at this crossing due to

Figure 4-5, South Side Looking North at Raised Grade and Adjacent Land

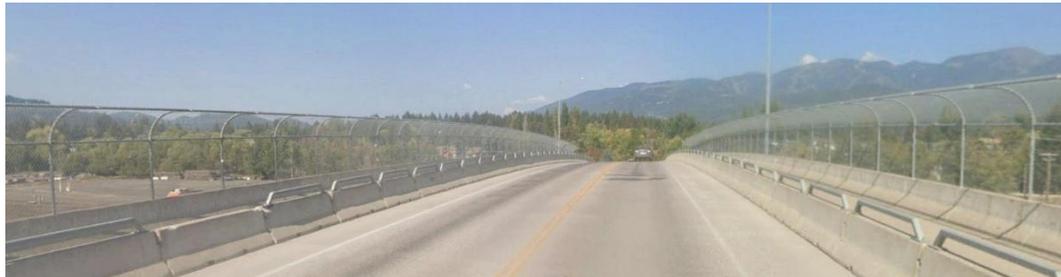
Baker Avenue, a minor arterial road owned and maintained by MDT, crosses the BNSF Whitefish yard. The crossing is a public grade separated highway overpass built in 2014. The overpass bridge is a five span steel I-girder bridge with a concrete deck supported by four concrete piers and is approximately 412 feet long and 63 feet wide. The bridge supports 2~12-foot lanes, 10-foot shoulders on each side (NOTE, recently the City of

Figure 4-6, View on Baker Ave. Bridge looking North (Google Earth)

Whitefish shifted the precast concrete median barriers 4-feet, reducing the shoulder to 6-feet and providing a wider 10-foot use walkway on each side that was originally 6-feet. The walkway is separated from the roadway by precast concrete jersey rail and cast-in-place concrete jersey rail supports a fence on the outside of the walkways. The bridge was last inspected in 2024 and was given an overall rating of fair.

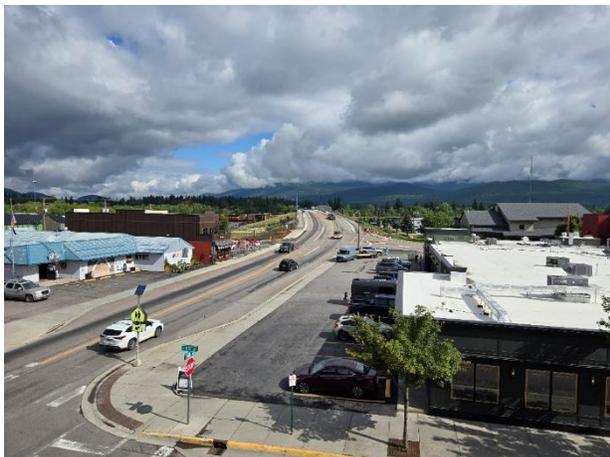
Figure 4-7, Baker Avenue Overpass – Viewed from South of Crossing

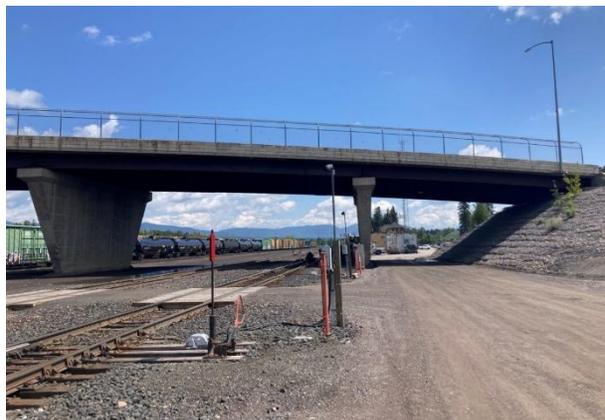
Figure 4-8, Baker Avenue Overpass – View from BNSF Yard Looking East

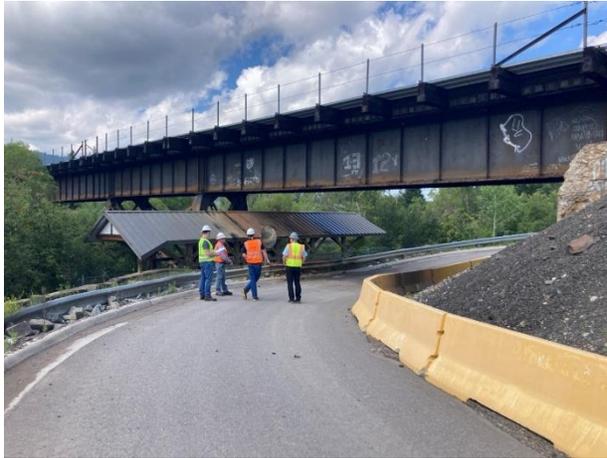
Figure 4-10, East End Whitefish River Bridge, south side looking north under Span 1, BNSF Roadway and Roof Over Shared Use path shown.

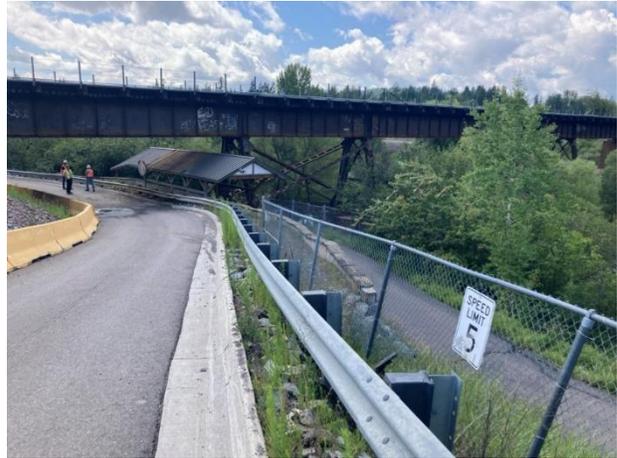
Figure 4-11, Whitefish River Bridge, North side looking south under Span 1, BNSF Roadway on left separated by fence from shared use path on right.

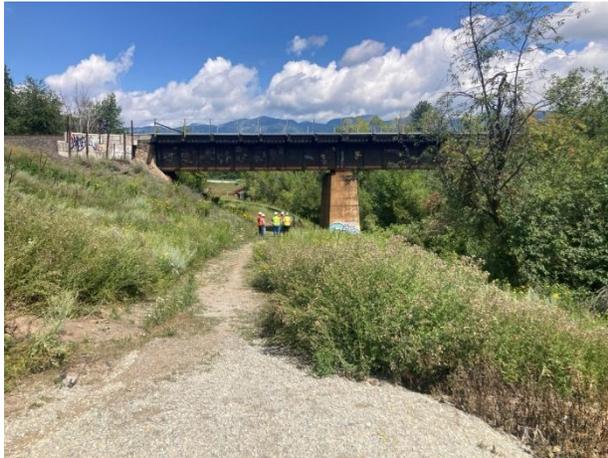
Figure 4-12, Whitefish River Bridge, West End Span 6 South Side Looking North at Prop'd Share Use Path Area.

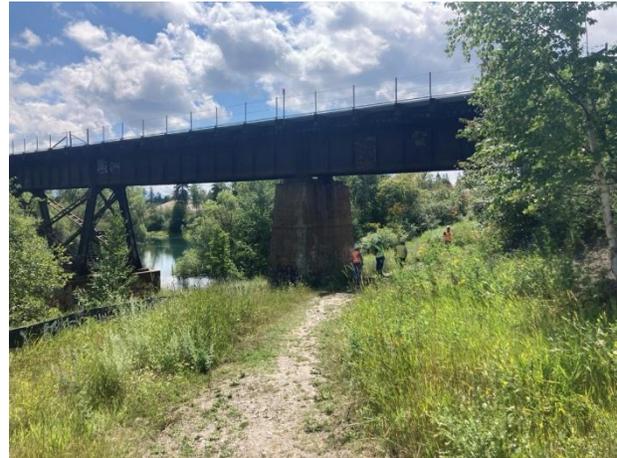
Figure 4-13, Whitefish River Bridge, West End Span 6, North Side Looking South at Prop'd Shared Use Path area.

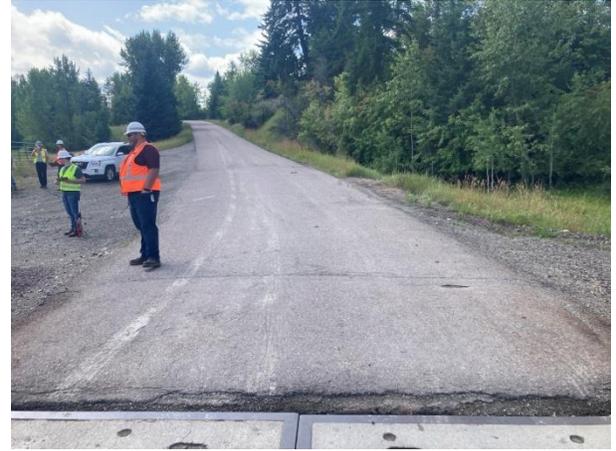
Figure 4-17, Birch Point Drive - At Crossing Looking South

The Birch Point Drive crossing includes active and passive warning devices. Active warning devices include crossing signal flashing lights and bells at the northwest and southeast quadrants. A signal bungalow for these devices sits in the northeast quadrant. Passive warning devices include signage. Crossbuck and FRA crossing signs are attached to the crossing signal poles in accordance with MUTCD requirements. A railroad crossing warning sign is present on the approach to the crossing from the north for southbound traffic but no RR crossing warning signs existing on the roads approaching the T-intersection. No roadway warning or stopping pavement striping exists for either northbound or southbound traffic and no warning signs are present for northbound traffic using the south approach to the crossing. No specific signage exists for bicycle/pedestrian users.

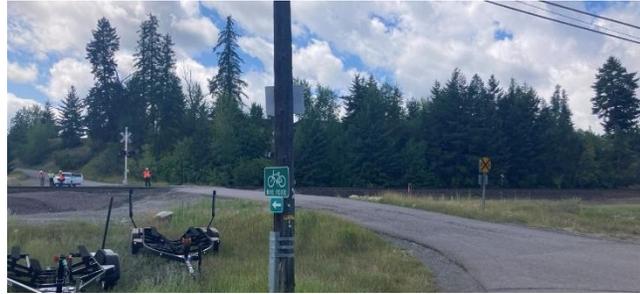
Stopping sight triangle distance for northbound vehicles approaching from the south is impacted by trees in the southwest quadrant that block views of trains approaching from the west from vehicles approaching the crossing from the south. Clear sight distance at the crossing itself is not impeded in either direction along the tracks except for the extents of the track curvature that extends west from the crossing.

Figure 4-18, Birch Point Crossing from NE quadrant looking Southwest at trees/vegetation in SW quadrant

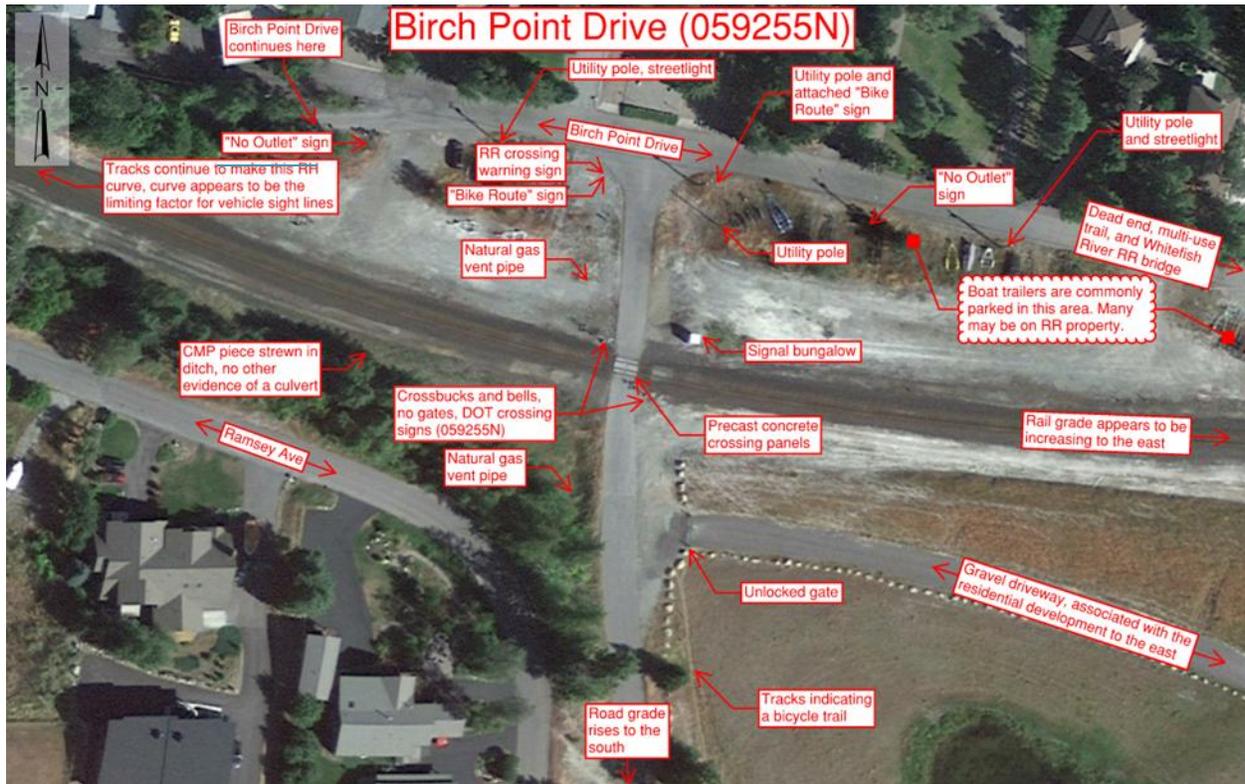
Figure 4-19, Birch Point Drive - Aerial Observation Notes

Visible items observed during the site visit are also shown in the aerial view, **Error! Reference source not found.**

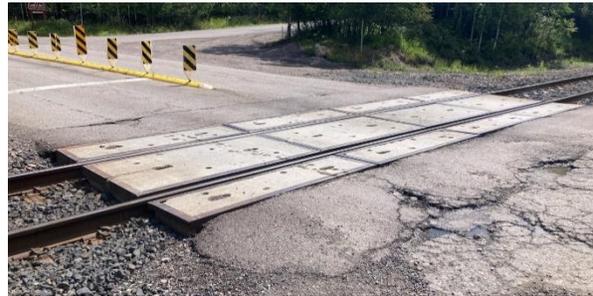
The single main track is on a tangent alignment through the crossing area. The asphalt paved roadway, consisting of 2-twelve foot lanes with concrete curb and gutter and sidewalk on the west side up to 130-feet of the crossing has no marked shoulders with cracks and uneven surface in the crossing area especially on the north side of the crossing, Figure 20. The south approach extends to the tracks from the south-east and then curves north making an approximate 50-degree turn with the west end of the curve approximately ending at the tracks and then crosses the tracks at right angles, extending north to access the Whitefish Lake State Park and residential access roads. There are no concrete curb and gutter features on the north side approach to the crossing. The crossing has been upgraded to a “Quiet Zone” crossing with center median dividers with Type 3 Object Marker Signs placed between the northbound and south bound lanes on the approaches to the crossing. A single cantilever arm and mast is located on the south side of the crossing supporting overhead flashing lights visible to vehicle traffic approaching the crossing from both directions. The masts on either side also support cross-bucks, FRA Crossing ID signs, the horns and additional lights in accordance with quiet zone warning requirements. No provisions for bicycle/pedestrian features exist at the crossing, although a sidewalk along the “west” side of the road terminates approximately 140-feet south from the crossing.

Figure 4-20, Asphalt Roadway Approaches to the Crossing , Looking Northeast from Southwest

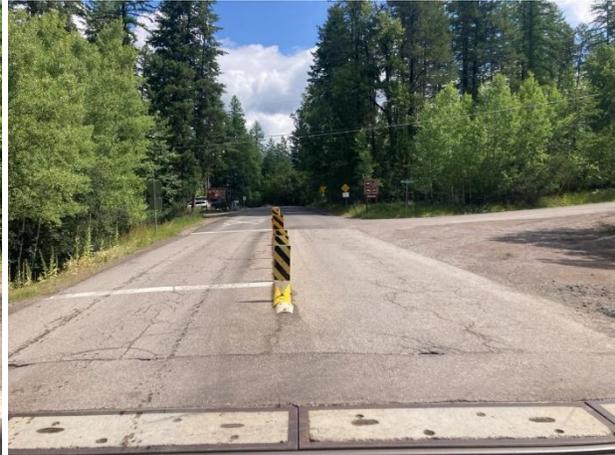
Figure 4-24, State Park Road - Looking North from the Crossing

Stopping sight triangle distance for vehicles approaching the crossing from both directions is impacted by trees in all quadrants. However, sight distance at the crossing itself along the tracks is not impacted by trees or vegetation. However, as shown in Figure 4-24, northbound traffic approaching the curve and tracks cannot see trains nor the crossing signals until the approach curve is reached due to the trees and vegetation between the road and tracks.

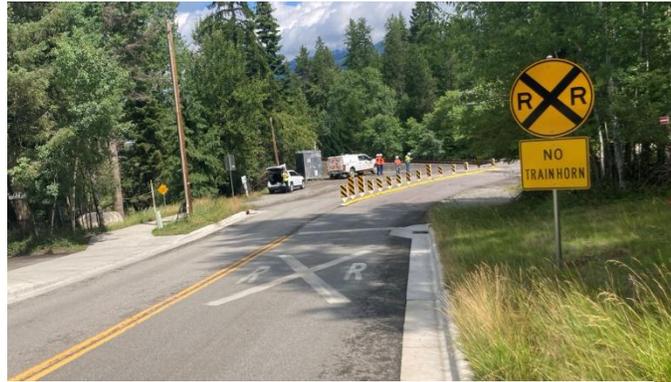
Figure 4-25, Northbound Approach Typical Crossing Sight Triangle

Safe sight triangle distance approaching the crossing from the south may cause some concerns depending on vehicle and train speeds.

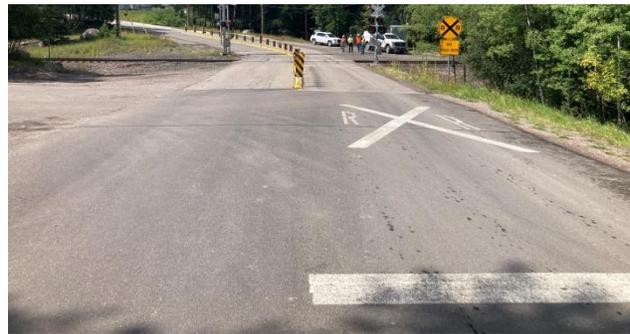
Vehicles approaching from the north may have a clear view of the crossing signals, but due to the trees and vegetation, have no view of trains approaching the crossing to the west of the crossing as shown in Figure 4-25. Similar from this approach, vegetation also blocks to view to the east of the crossing.

Figure 4-25, View from North of the Crossing showing Vegetation Blocking View to the Right (West)
